**Confirmation Sampling and Analysis Report
for the BX Service Station, Facility 736, Site ST-29**

**Patrick Air Force Base
Florida**

**CONFIRMATION SAMPLING AND ANALYSIS REPORT
FOR THE
BX SERVICE STATION, FACILITY 736, SITE ST-29
PATRICK AIR FORCE BASE, FLORIDA**

Contract F41624-92-8036, Delivery Order 17

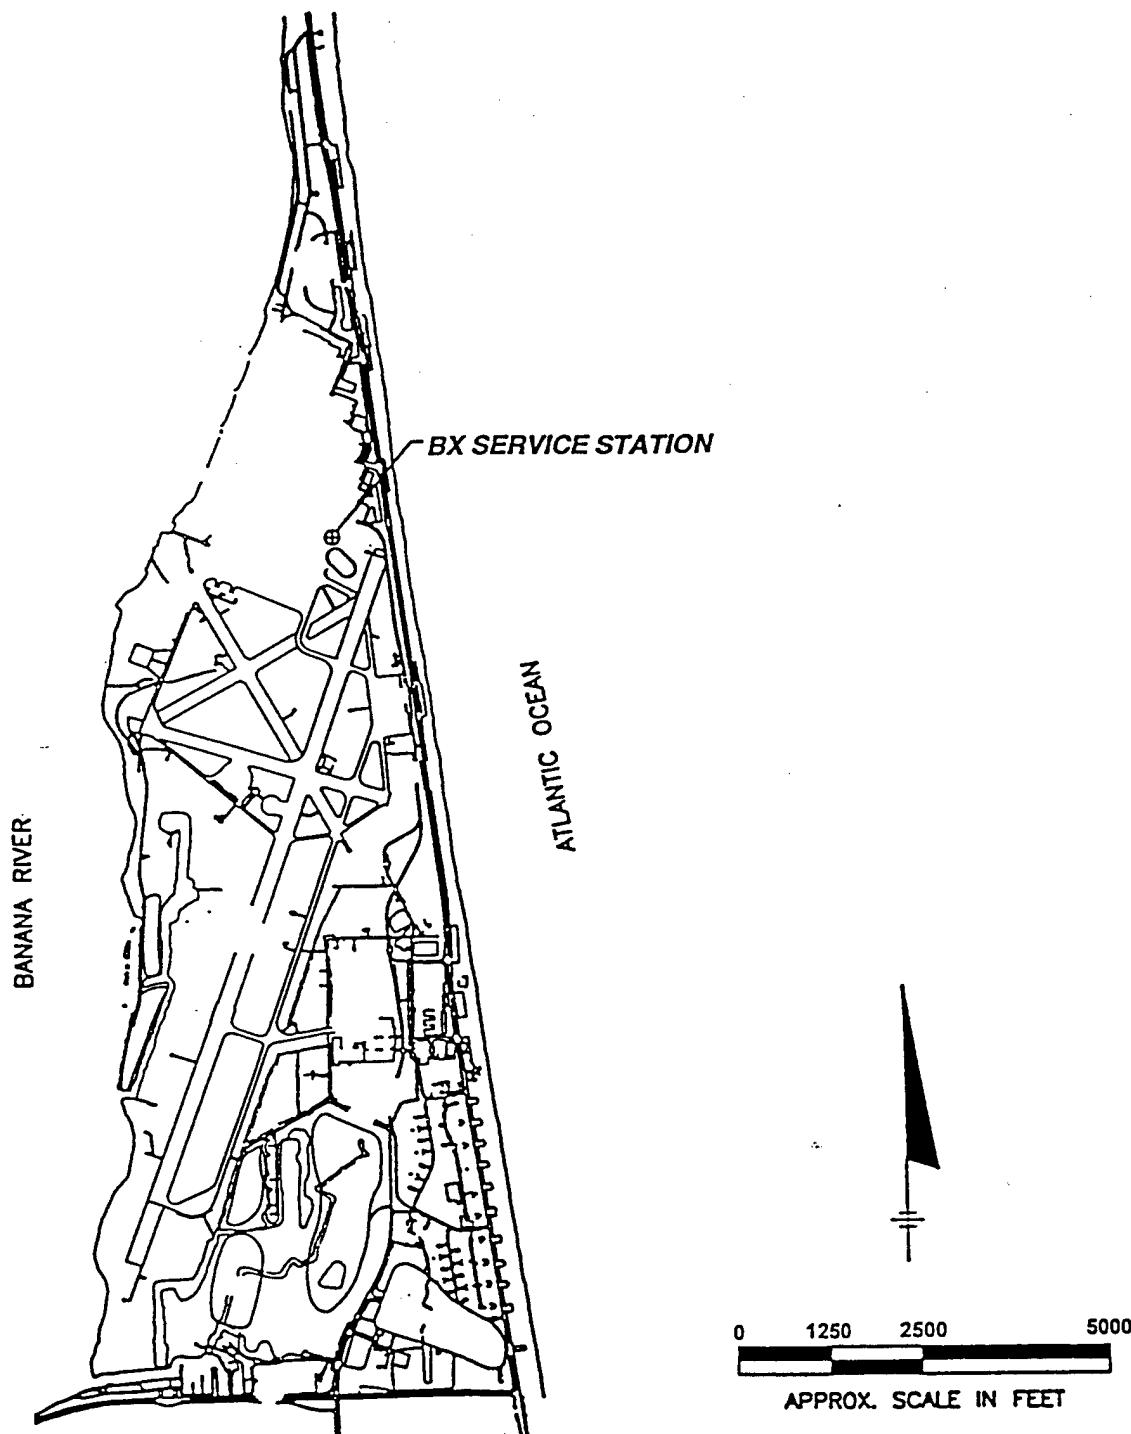
FIGURE 1.1

SITE LOCATION

Patrick AFB lies on a long barrier island situated off Florida's east coast, in Brevard County. Patrick AFB is bounded on the east by the Atlantic Ocean and on the west by the Banana River. The City of Cocoa Beach is located immediately north of the Base, and Satellite Beach is directly south. The BX Service Station is located in the north-central section of Patrick AFB (Figure 1.1). A layout of the site is presented on Figure 1.2. The BX Service Station is located on a level ground surface covered primarily with asphalt and concrete pavement. Soils at this site consist of predominantly unconsolidated, poorly to moderately well-sorted, fine- to coarse-grained quartz sand with up to 40-percent shell fragments. This marine sand deposit extends to approximately 25 feet below ground surface (bgs). Shallow groundwater at the site is unconfined and typically encountered in the sand at approximately 4 to 6 feet bgs. Historical groundwater elevation data indicate that groundwater flow at the site is generally to the west (Environmental Science & Engineering, Inc. [ESE], 1991; Parsons ES, 1995a).

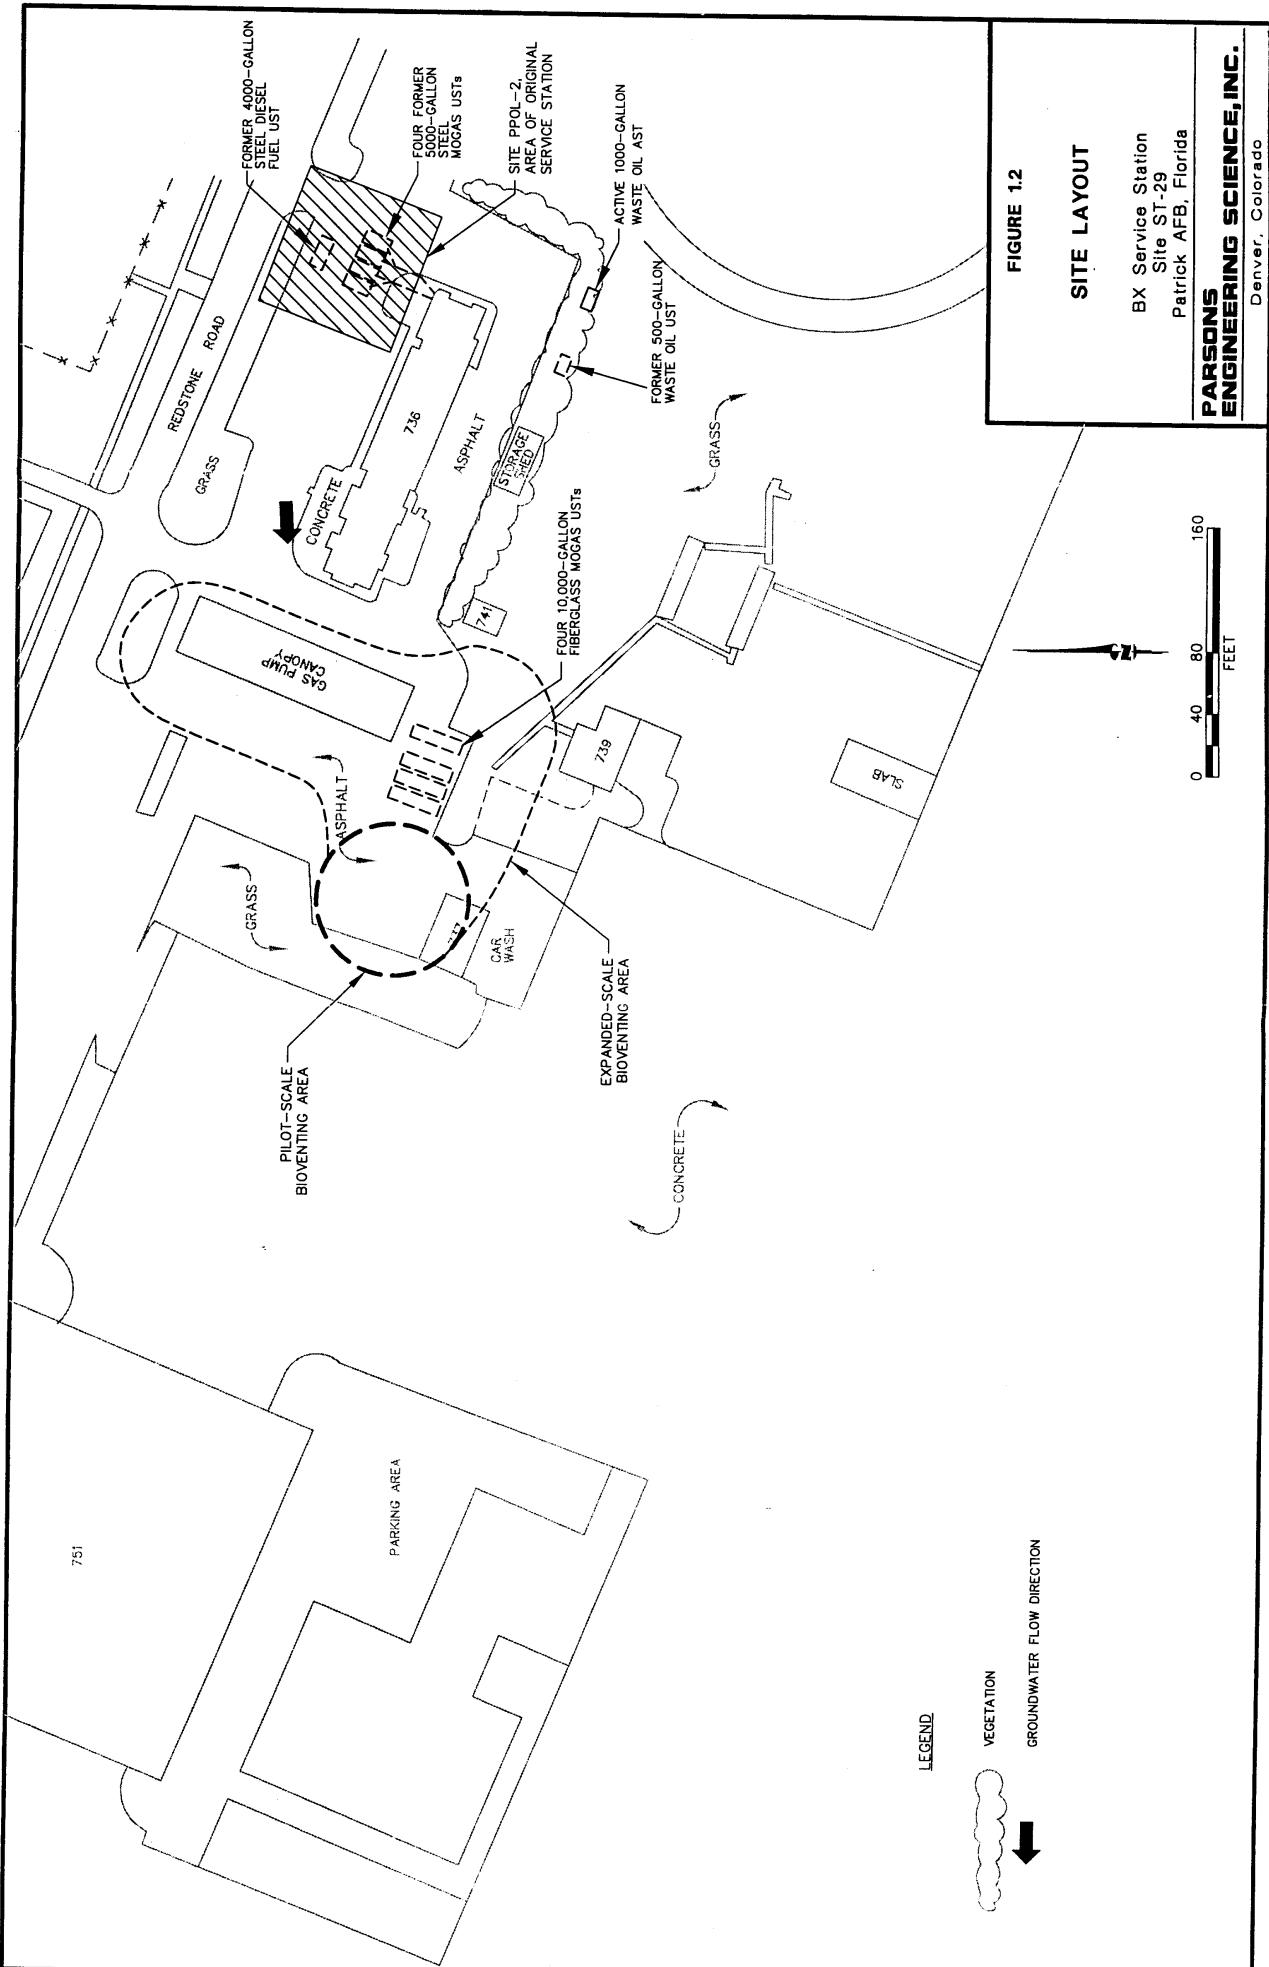
The original service station area is located to the northeast of Building 736, as shown on Figure 1.2. The original service station (Site PPOL-2) consisted of four former 5,000-gallon steel underground storage tanks (USTs) that contained motor vehicle gasoline (MOGAS), a former 4,000-gallon steel UST that contained diesel fuel, and two former dispenser islands and associated piping. The former dispenser islands were located above the USTs. During a major renovation in 1973, the dispenser islands were removed. The original USTs were abandoned in place, and the original service station area was paved with asphaltic concrete.

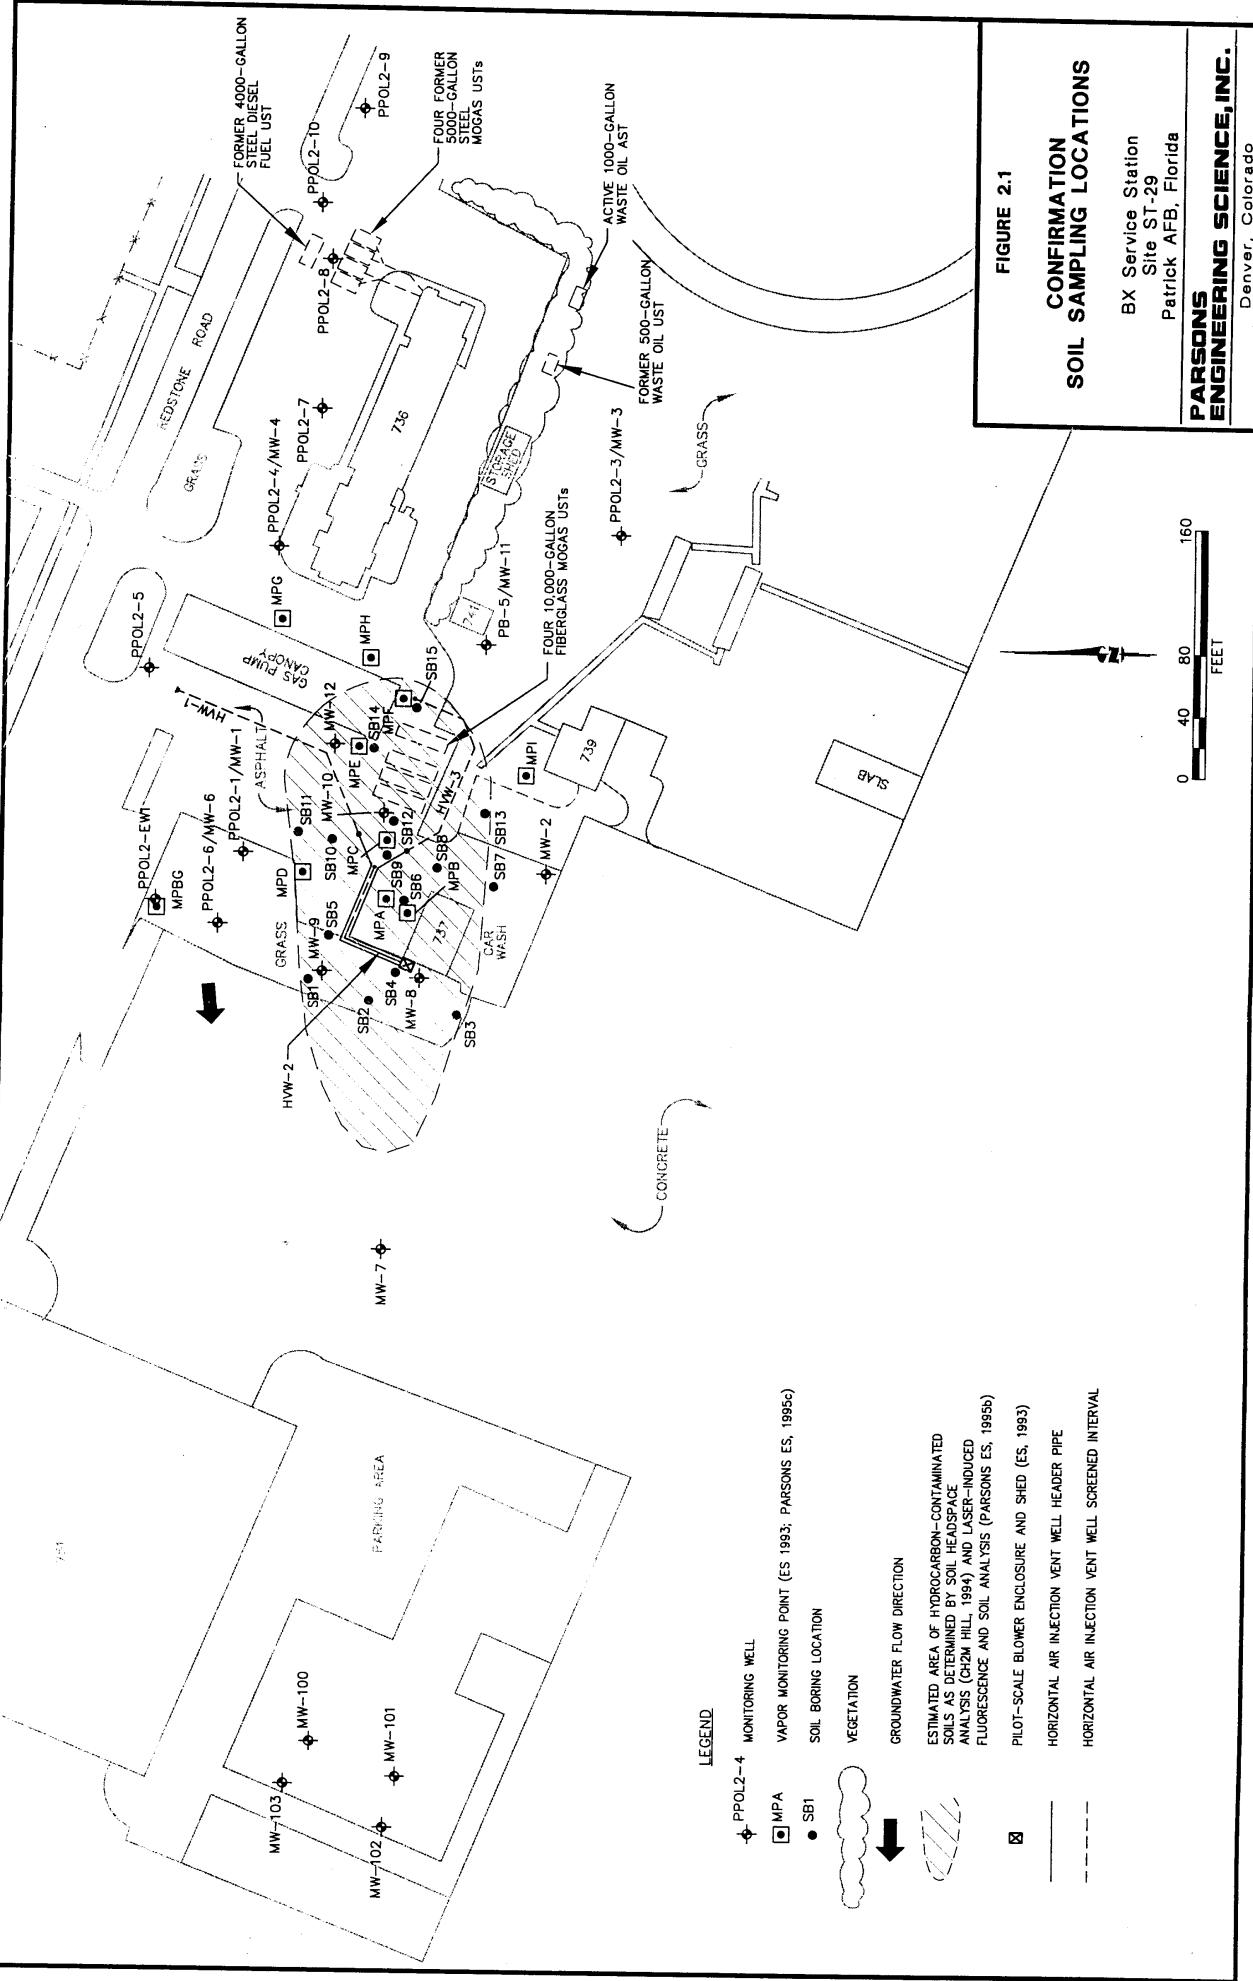
FIGURE 2.1

SOIL CONFIRMATION SAMPLING LOCATIONS

Based on field screening results, one sample from each boring (SB1 through SB15) was selected and submitted for laboratory analysis using laboratory-prepared containers. Replicate samples also were collected from boreholes SB1 and SB15.

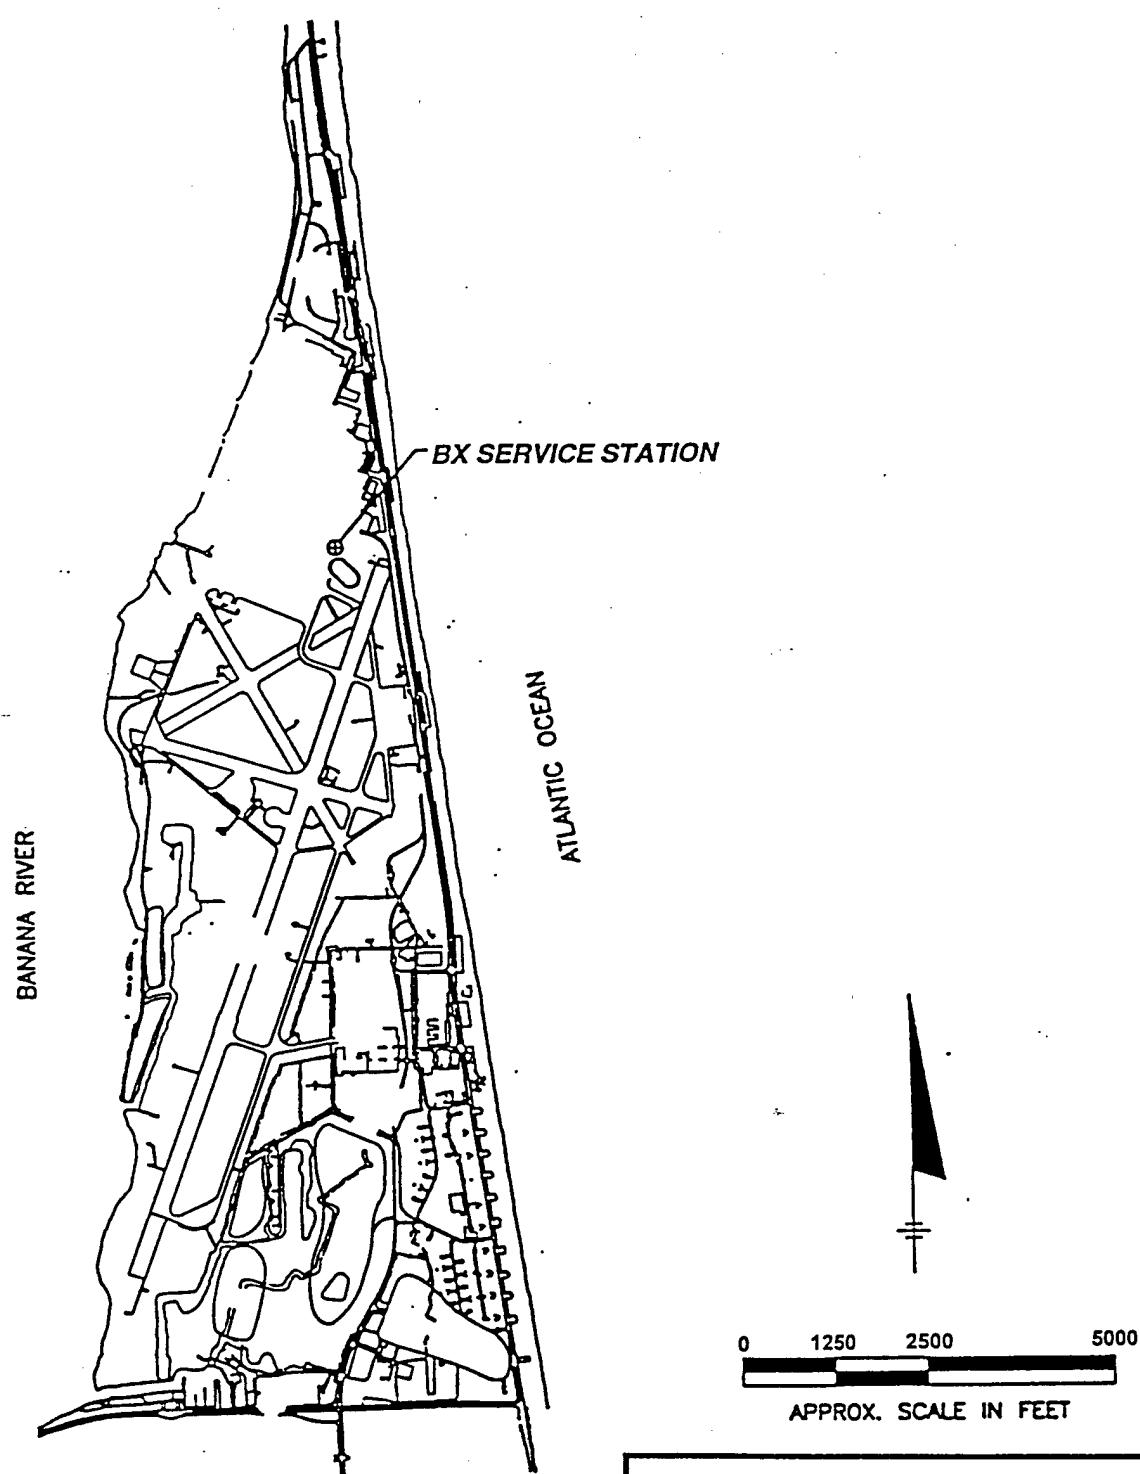
FIGURE 2.1

SITE LOCATION

Patrick AFB lies on a long barrier island situated off Florida's east coast, in Brevard County. Patrick AFB is bounded on the east by the Atlantic Ocean and on the west by the Banana River. The City of Cocoa Beach is located immediately north of the Base, and Satellite Beach is directly south. The BX Service Station is located in the north-central section of Patrick AFB (Figure 2.1).

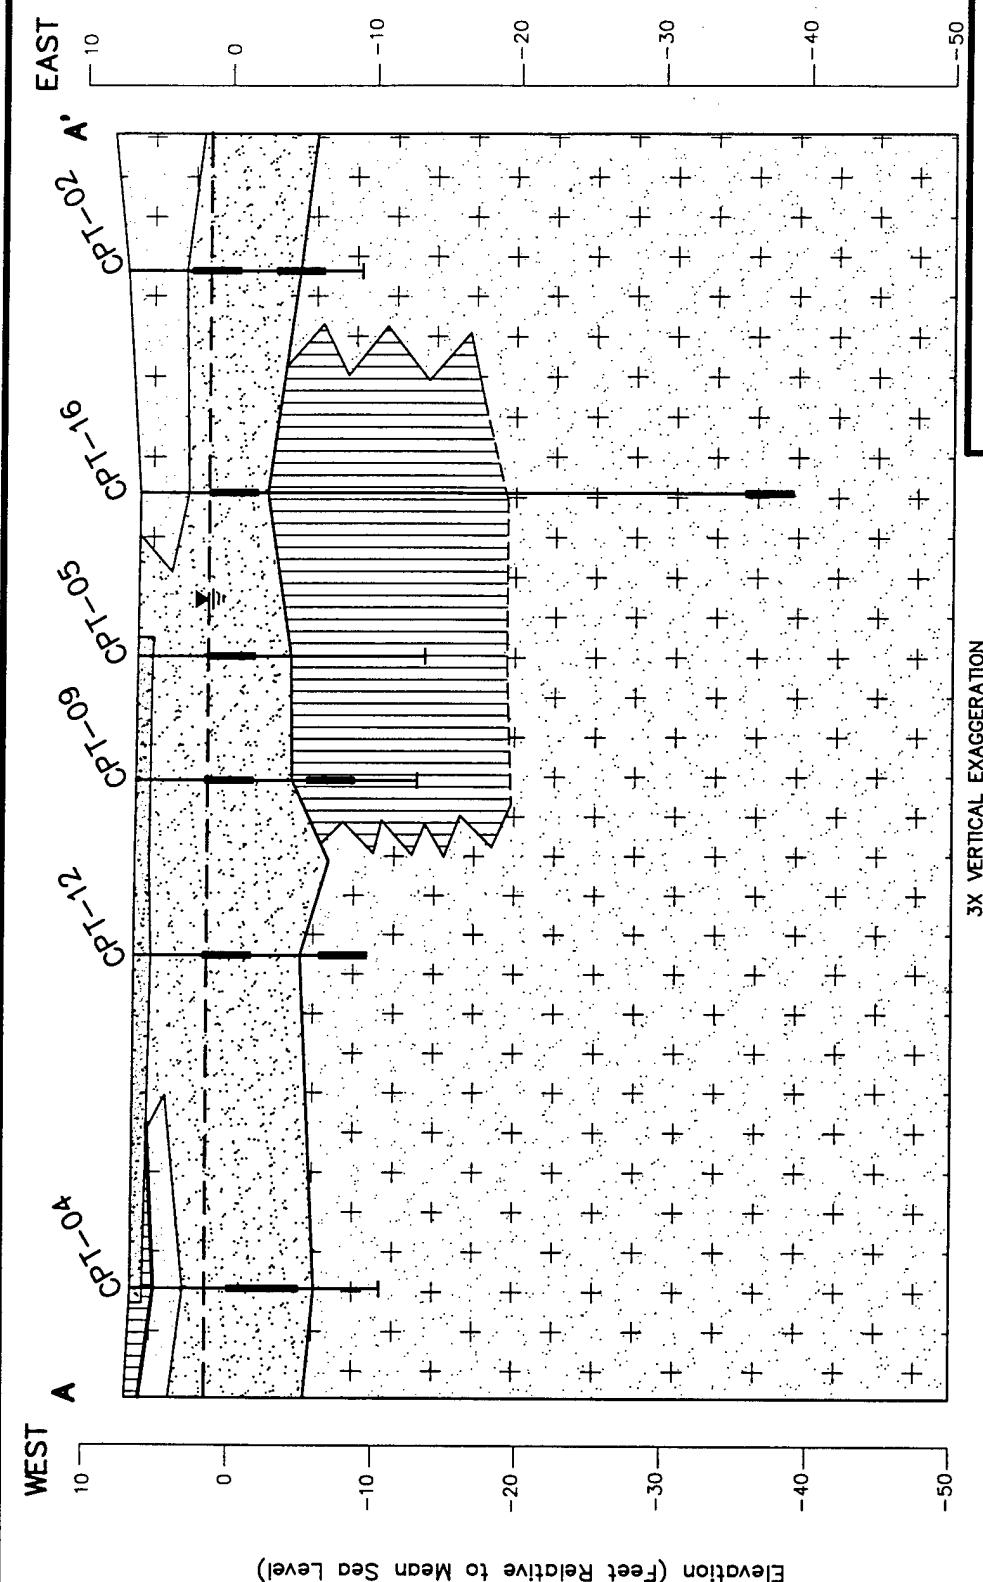
FIGURE 2.4

**HYDROGEOLOGIC
CROSS-SECTION A-A'**

The BX Service Station is characterized by a level ground surface covered primarily with asphalt and concrete pavement. Soils at this site consist of predominantly unconsolidated, poorly to moderately well-sorted, fine- to coarse-grained quartz sand with up to 40-percent shell fragments. This marine sand deposit extends to approximately 25 feet below ground surface (bgs). Figure 2.3 shows the locations of two hydrogeologic cross-sections, which are shown on Figures 2.4 and 2.5.

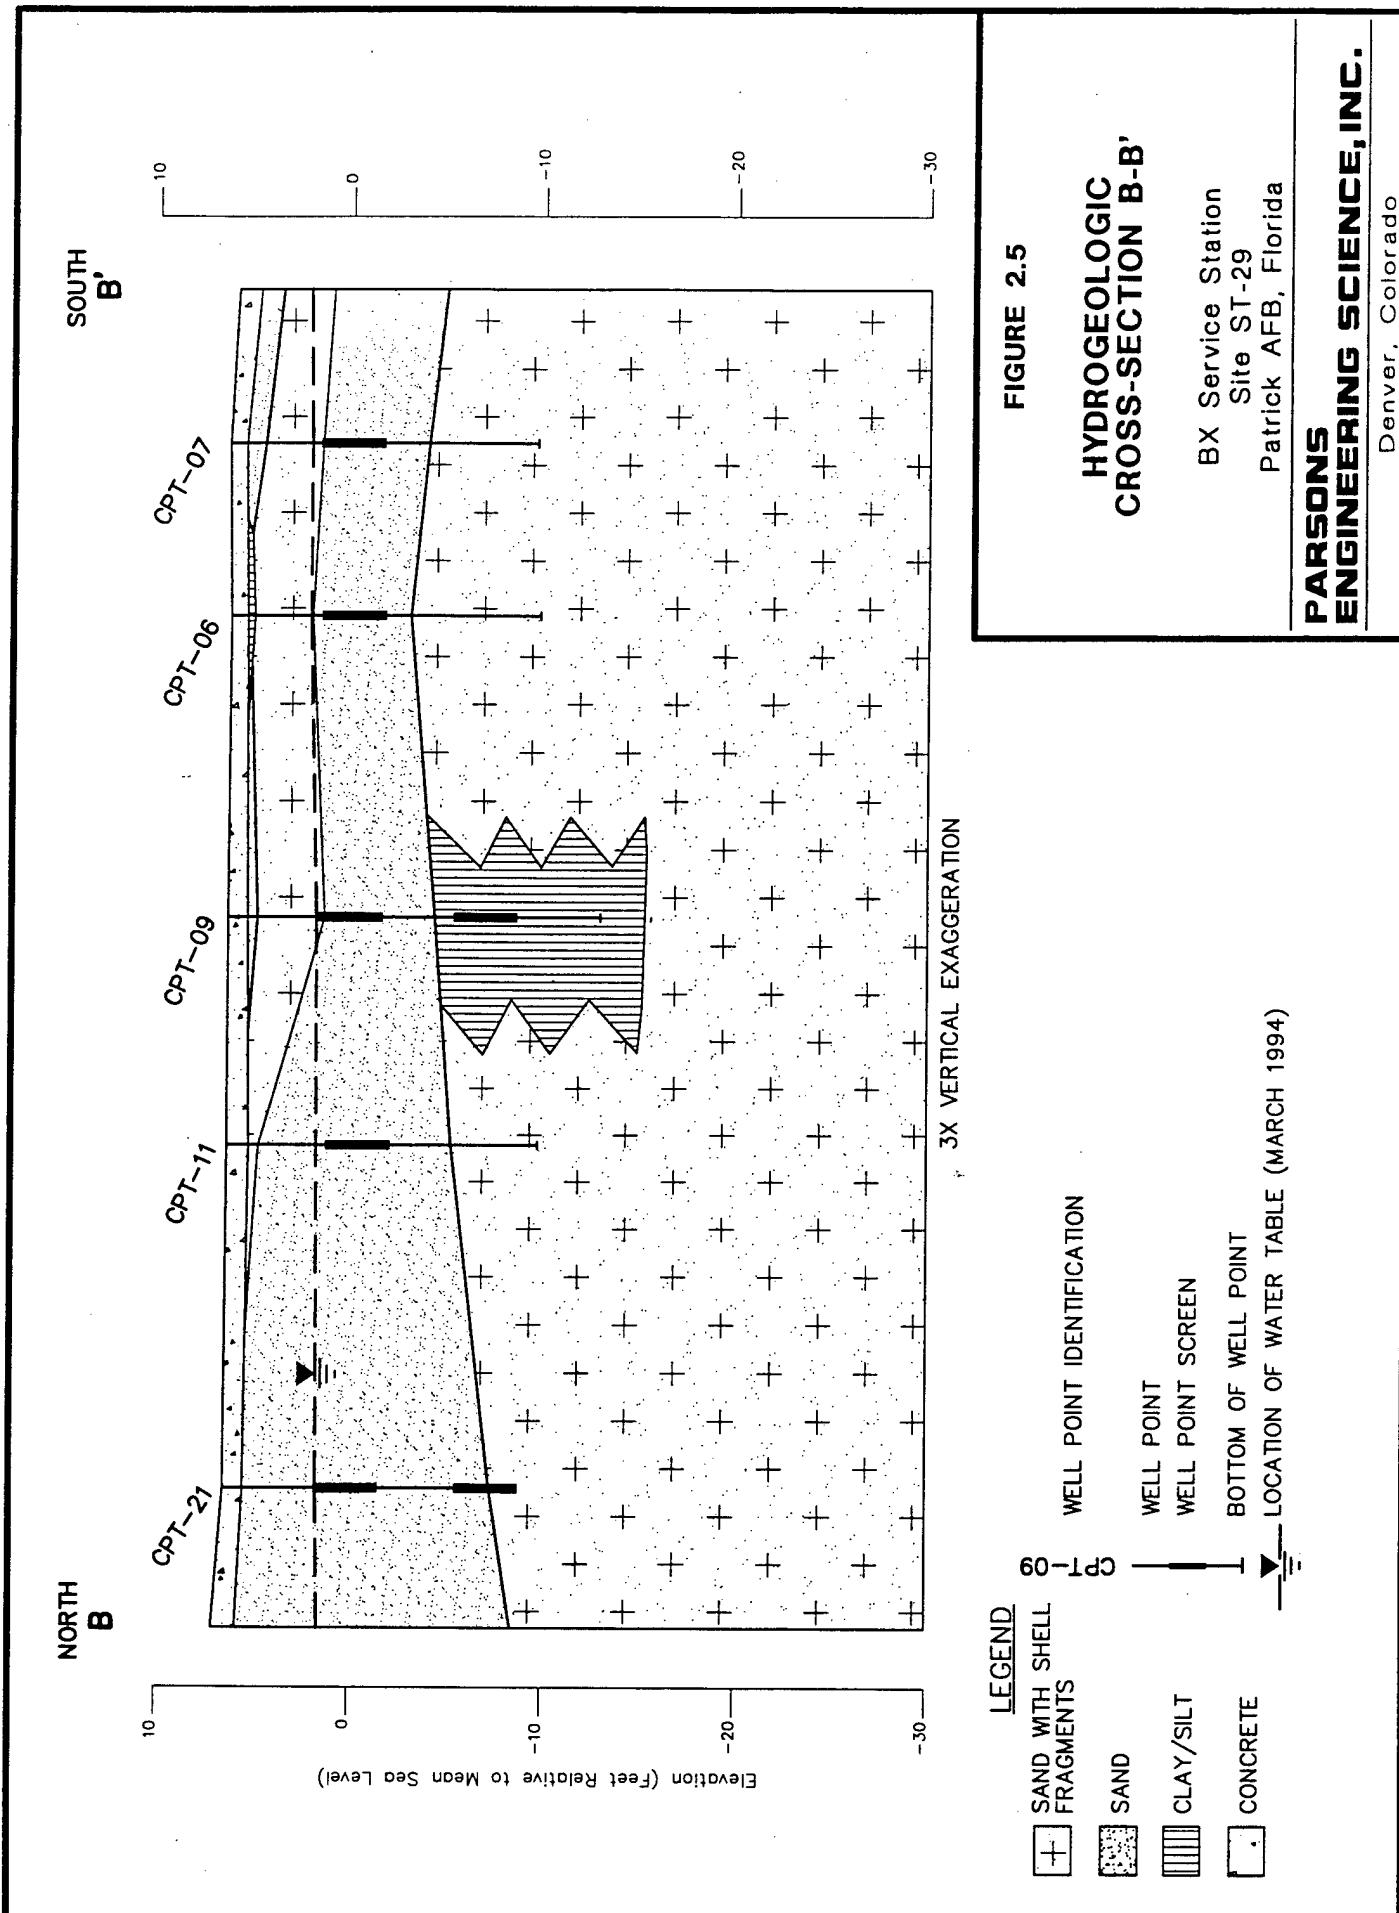
FIGURE 2.5

**HYDROGEOLOGIC
CROSS-SECTION B-B'**

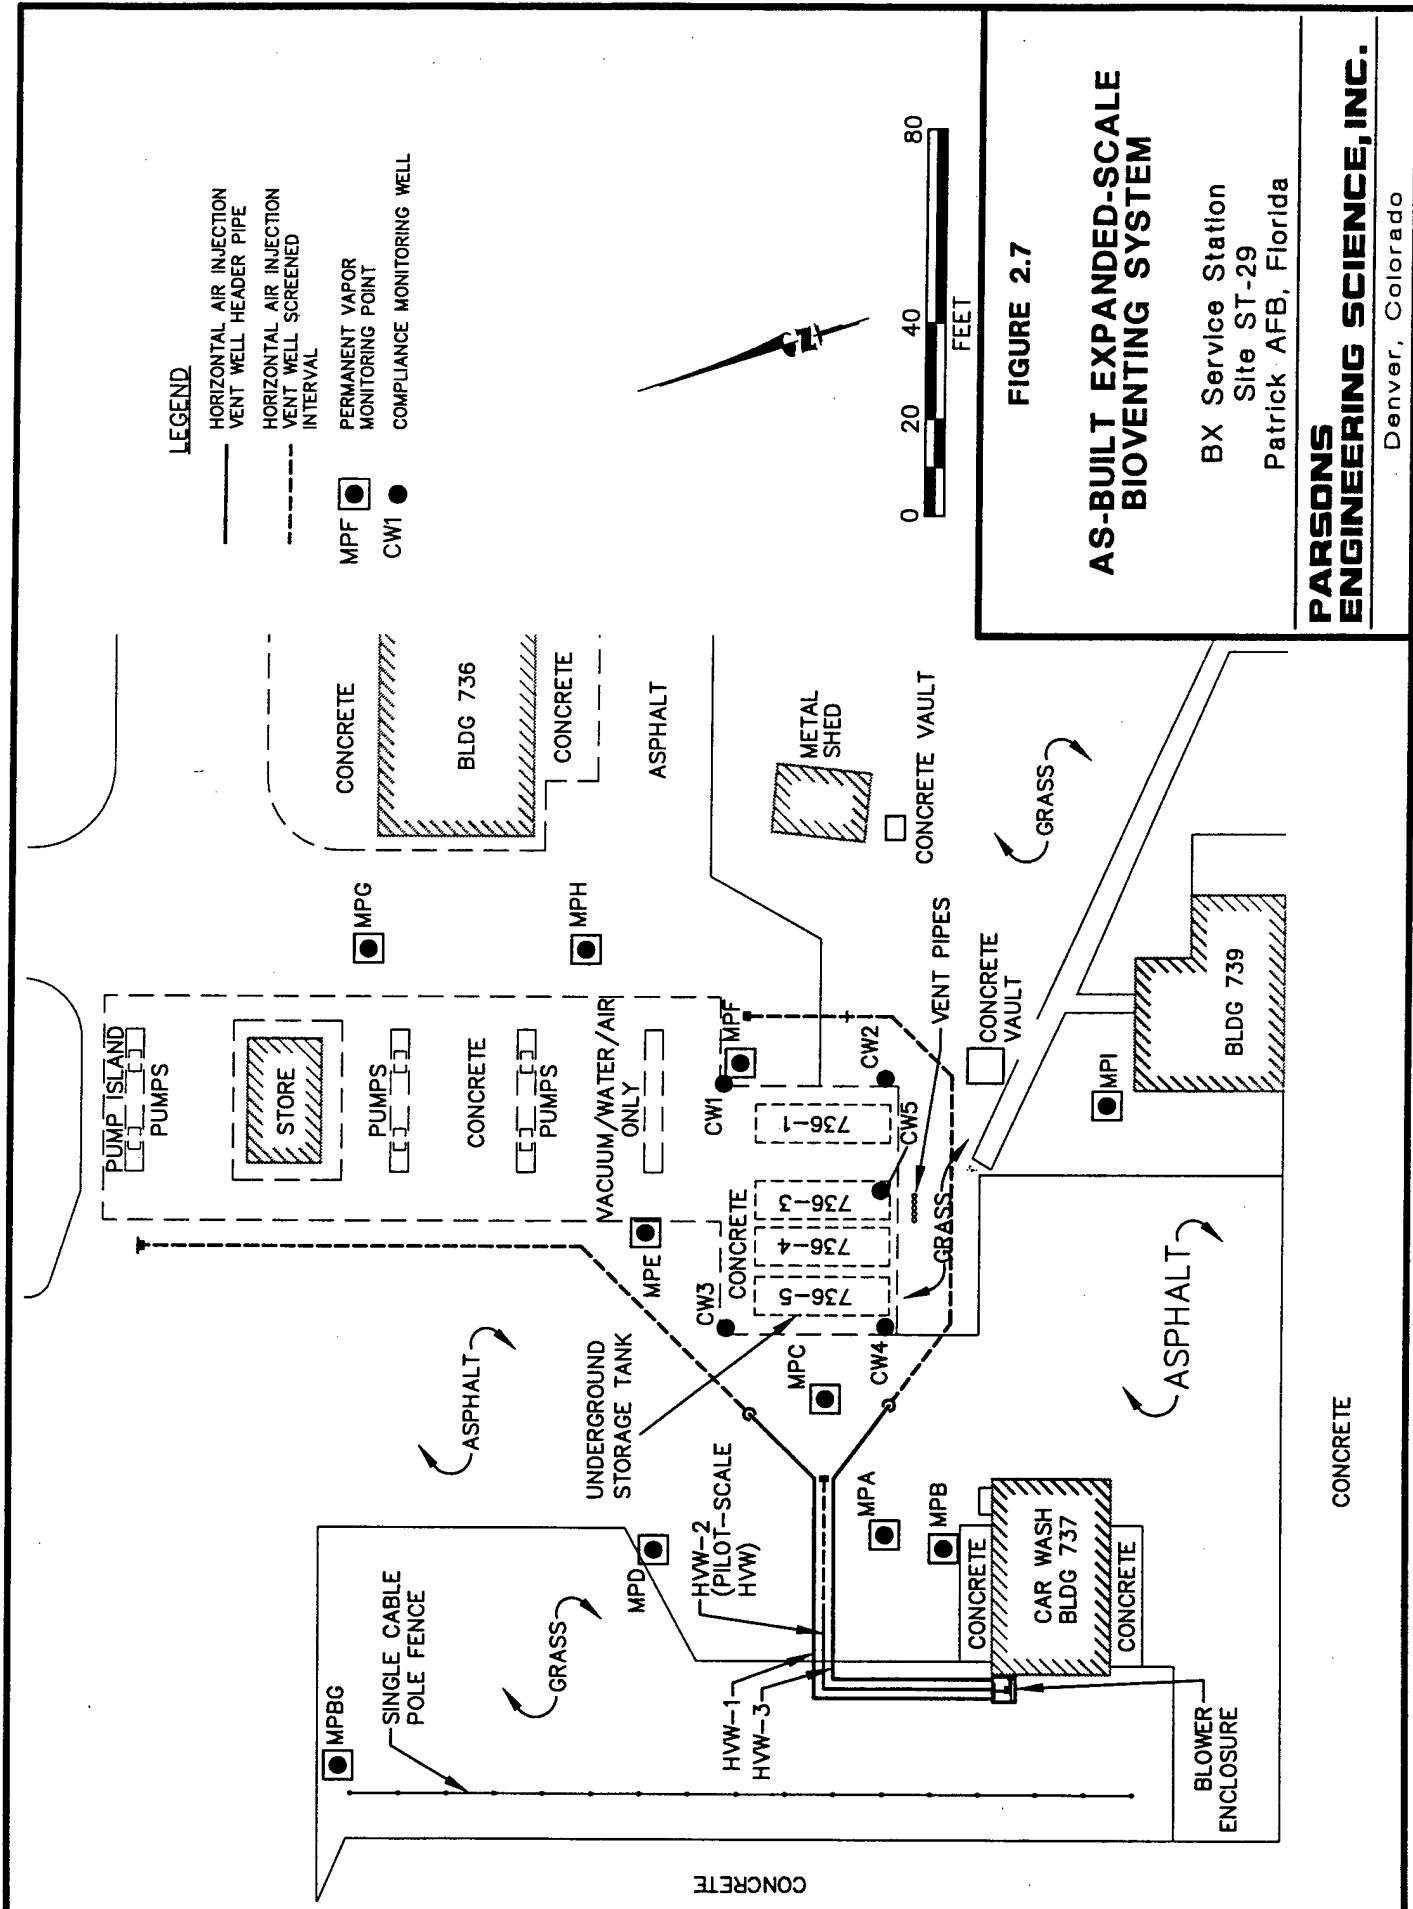
FIGURE 2.7

AS-BUILT EXPANDED-SCALE BIOVENTING SYSTEM

Soil samples also were collected from MPE, MPF, and compliance monitoring well CW2 (Figure 2.7) in July 1995 during bioventing system expansion. TRPH and BTEX concentrations in soils collected from MPE and MPF indicated these areas were moderately impacted by fuel hydrocarbon contamination. Significant contamination

With the exception of results from MPF, located on the east side of the active fiberglass USTs (Figure 2.7), field and analytical soil gas results from the November 1996 sampling event strongly suggested nearly complete remediation of hydrocarbon contaminants in soils at the BX Service Station site. Results of the March 1997 maintenance check demonstrated that MPF was receiving adequate oxygen (20.3 percent) for continued aerobic biodegradation of petroleum hydrocarbon contaminants in this source area (Parsons ES, 1997b).

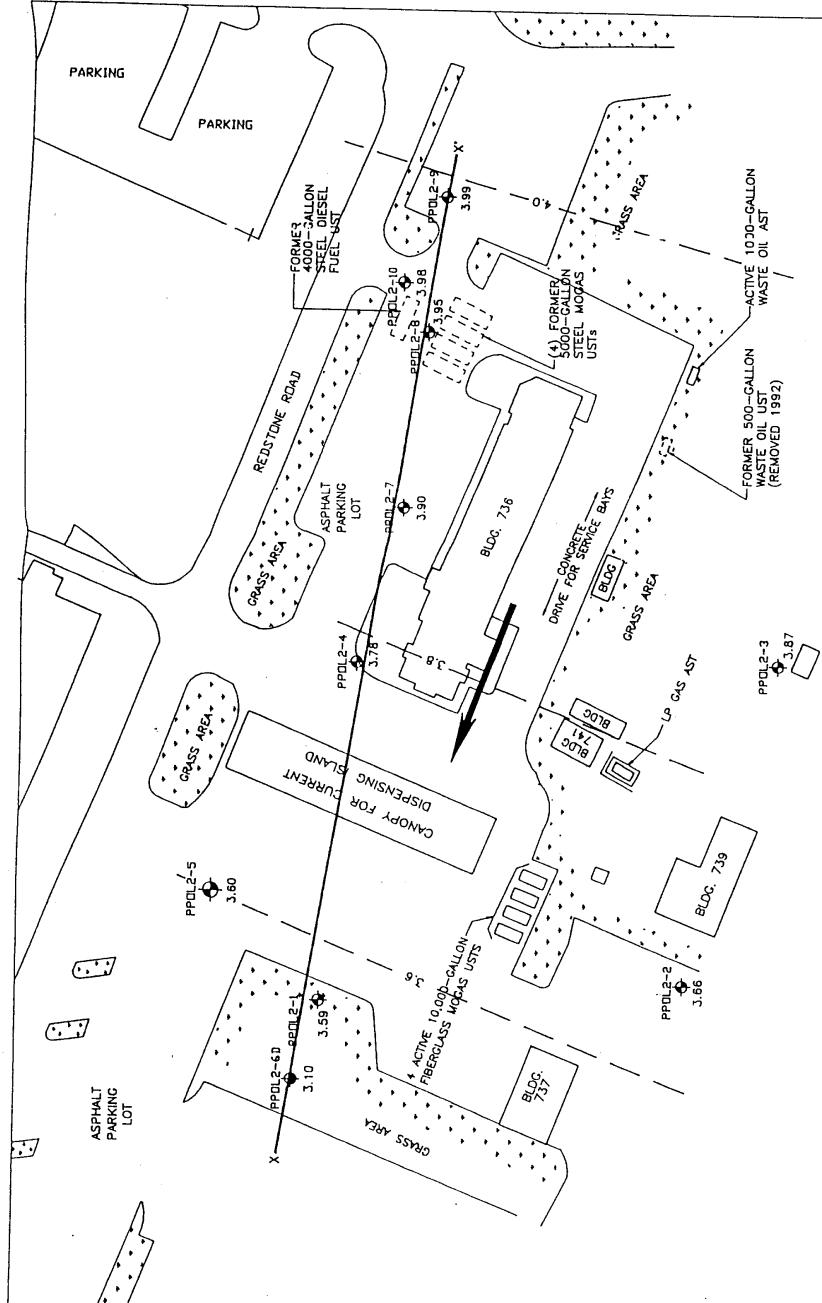
SITE ST-29 (PPOL-2)
GROUND WATER ELEVATION
CONTOUR MAP
(SEPTEMBER 29, 1994)

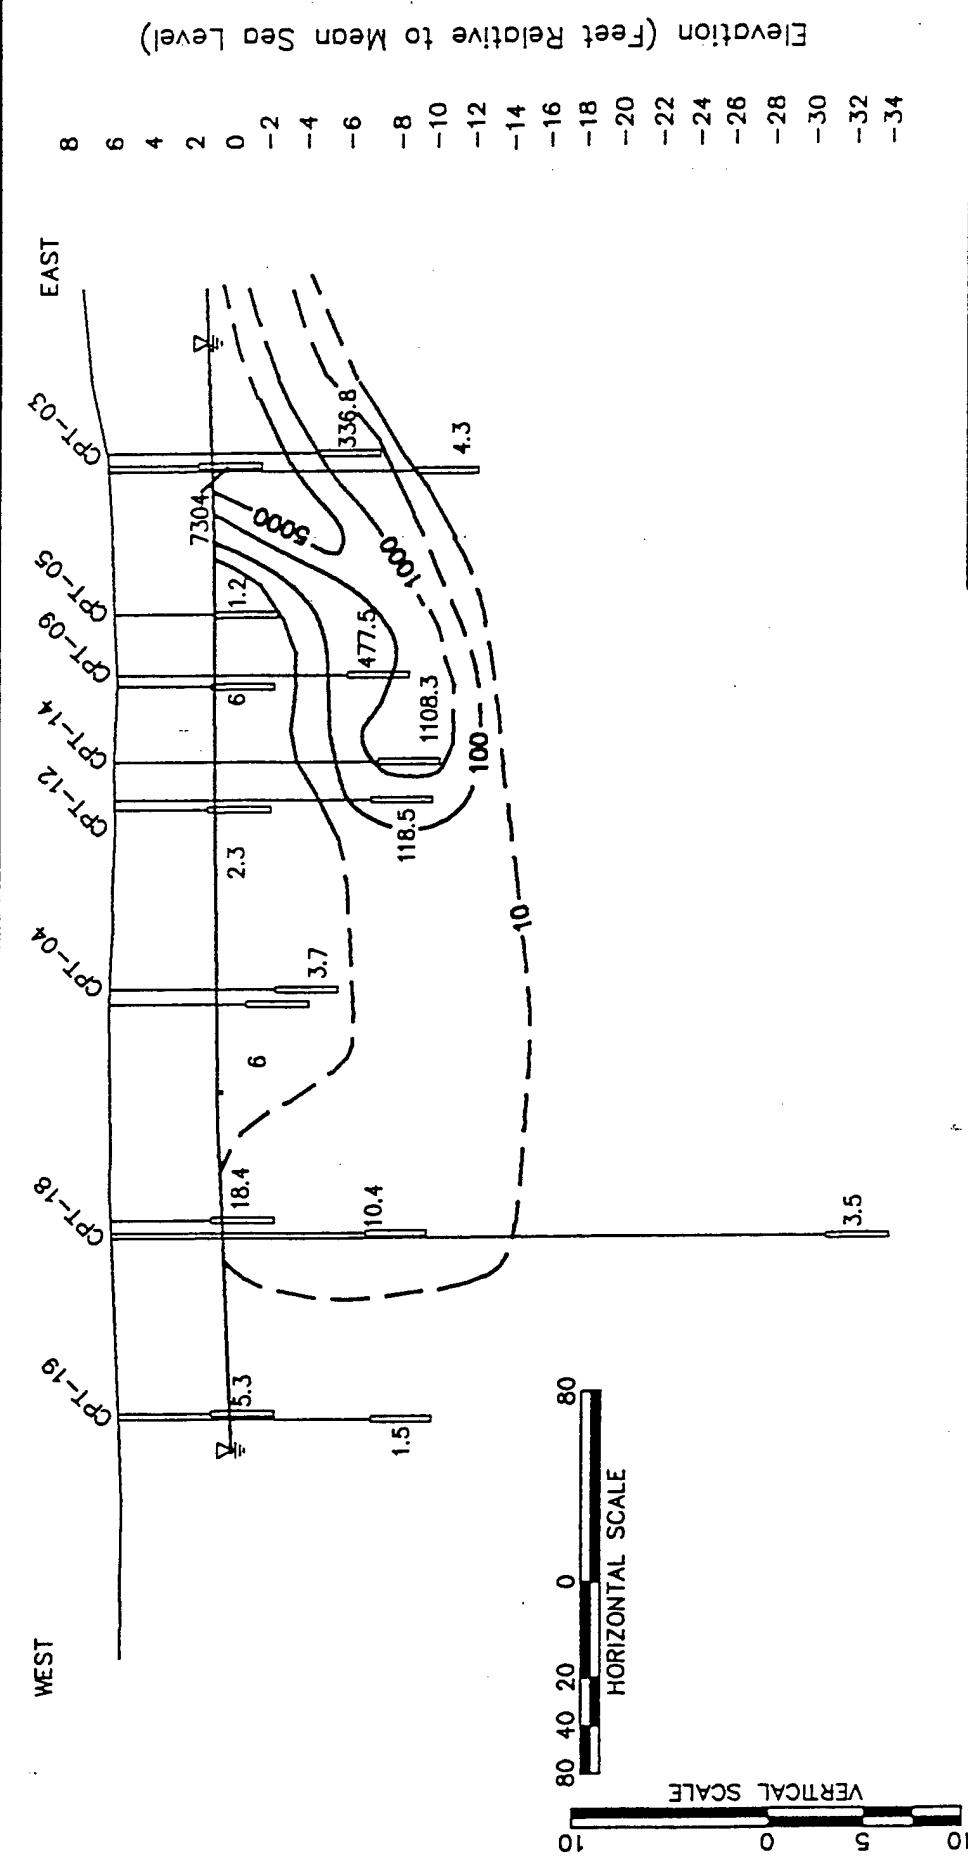
FIGURE 4.3

VERTICAL PROFILE OF
TOTAL BTEX ISOPLETHS
FOR GROUNDWATER
MARCH 1994

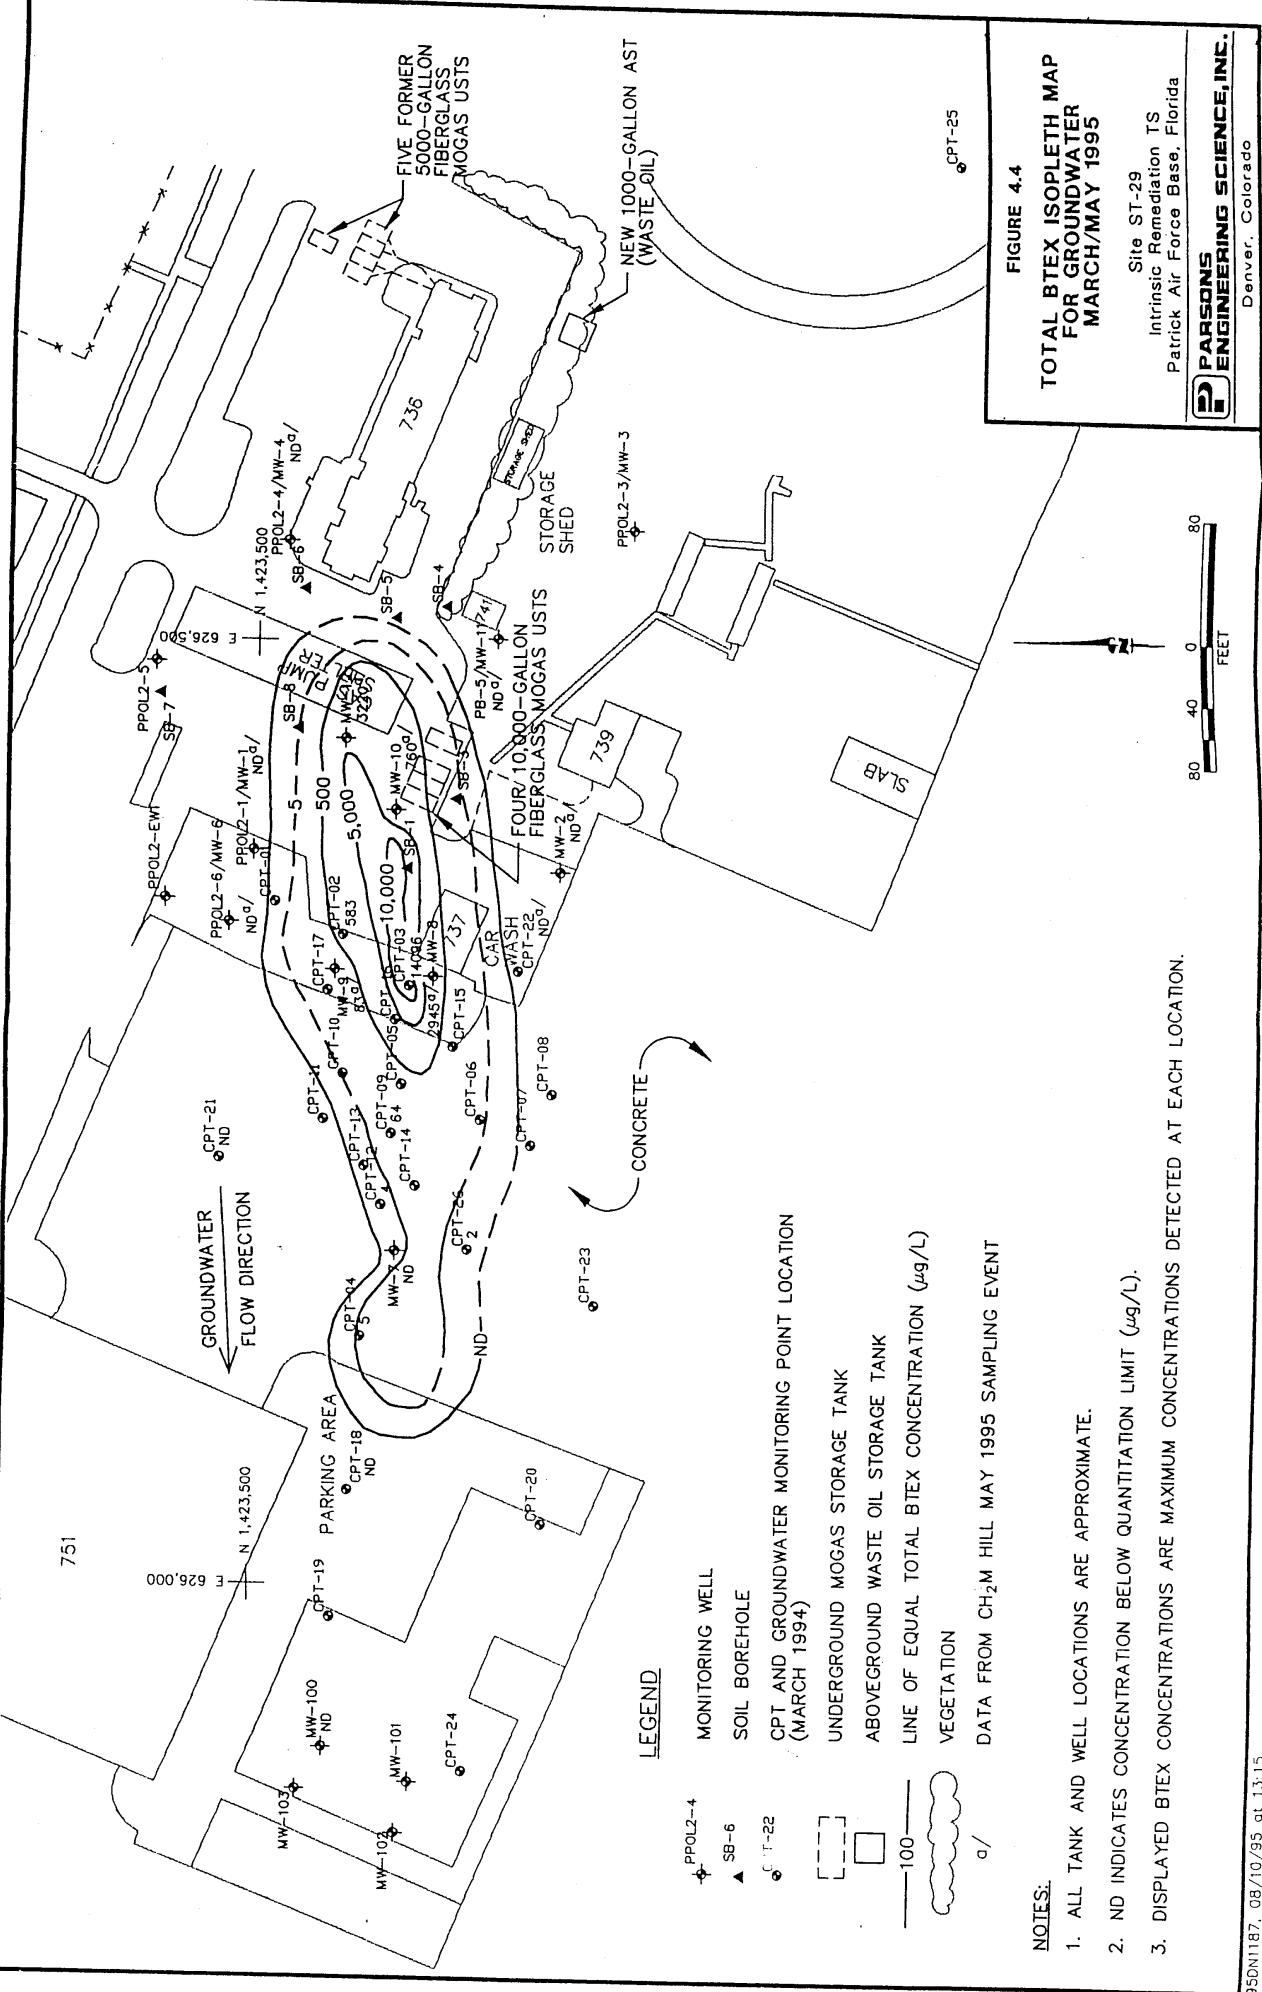
FIGURE 4.4

**TOTAL BTX ISOLETH MAP
FOR GROUNDWATER
MARCH/MAY 1995**

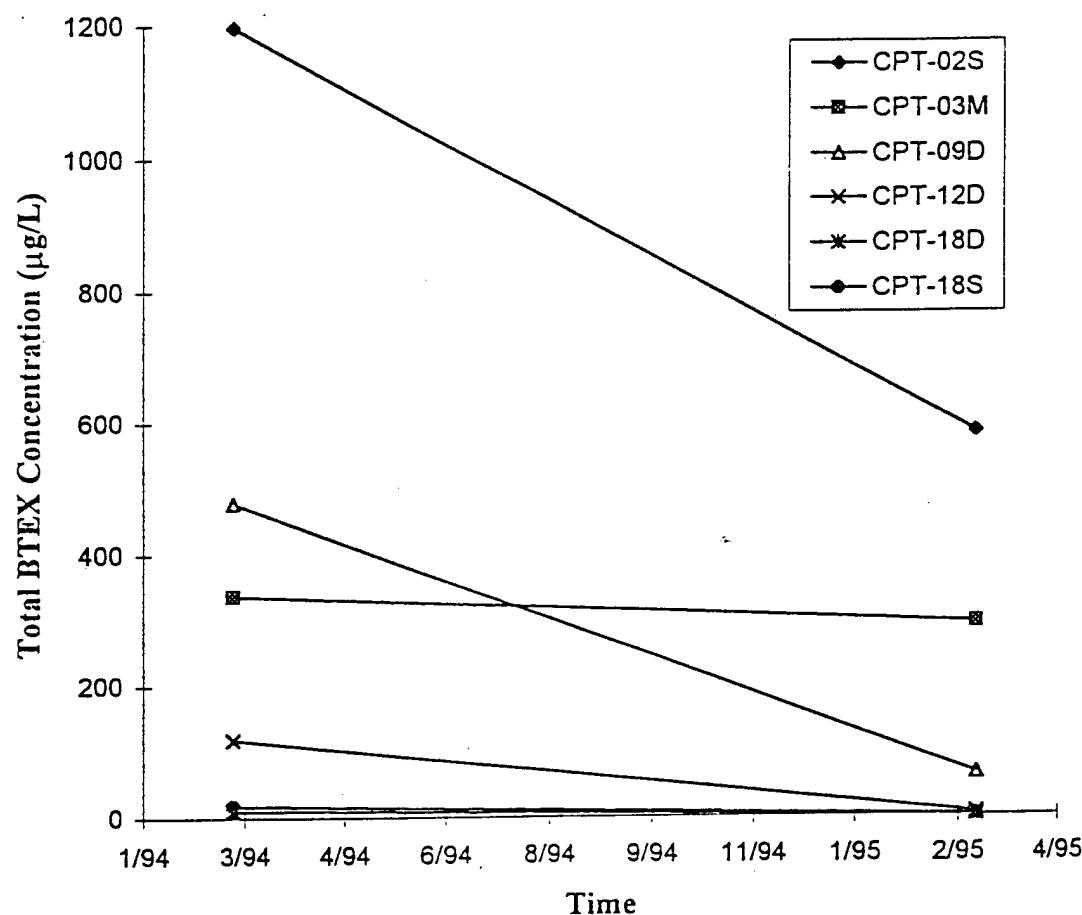
FIGURE 4.5A

PLOT OF TOTAL BTEX VERSUS TIME FOR SAMPLING LOCATIONS
WITH DECREASING BTEX CONCENTRATIONS
SITE ST-29 INTRINSIC REMEDIATION TS
PATRICK AFB, FLORIDA
